Joint Industry Programme on carbon monoxide issues

A review of carbon monoxide incident information for 1996/7 produced from the full investigation of incidents which had resulted from the use of piped natural gas and LPG within Great Britain

Prepared by
Advantica Technologies Limited
(formerly BG Technology)
for the Health and Safety Executive

CONTRACT RESEARCH REPORT
374/2001

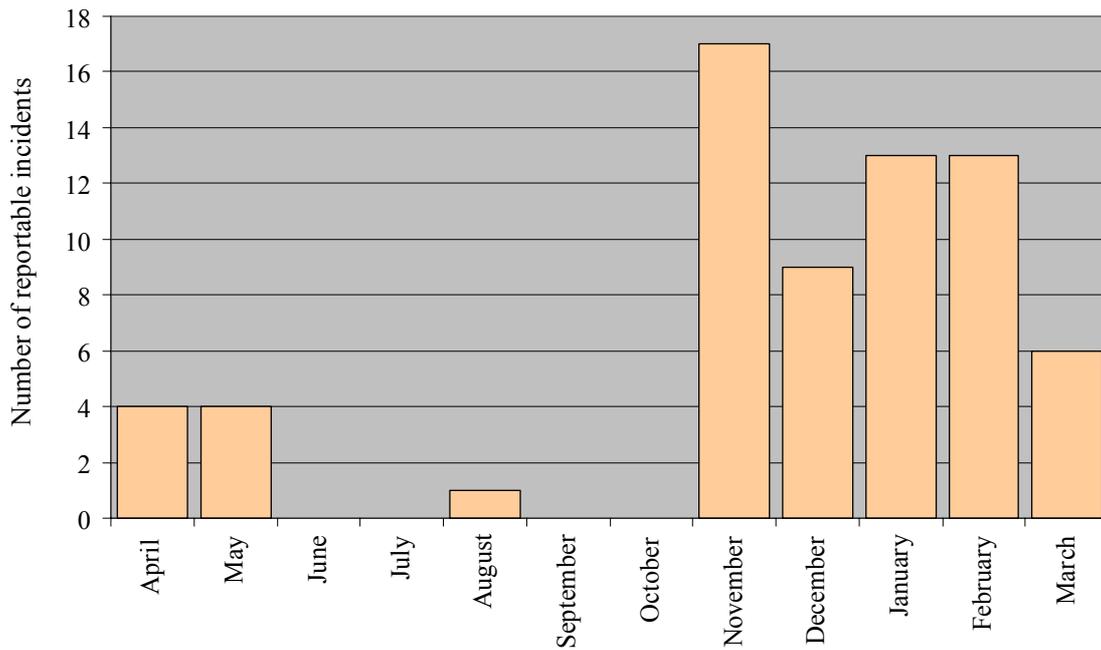
Figure 1 - Profile of incident occurrences over the year

The date of occurrence of each domestic incident has been plotted by month in Figure 1, for the 12 month period April 1996 to March 1997.

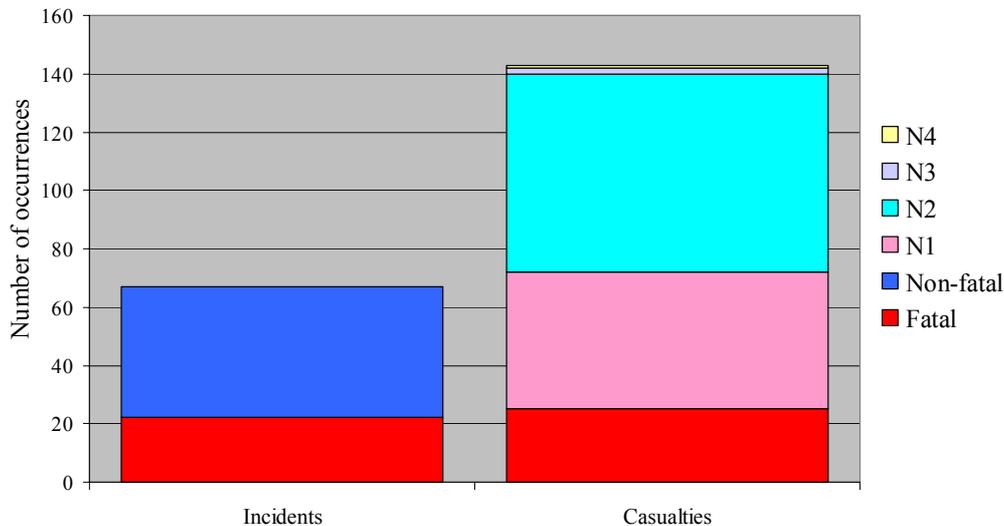
Figure 2 - Incident analysis

Figure 2 gives the number of reported domestic occurrences of CO incidents and CO casualties that took place during the year 1996/97. Further information on casualty groups are given in section 2.2 of this report.

Figure 2, in section 2.1, gives the number of occurrences of incidents and casualties that took place during the year.

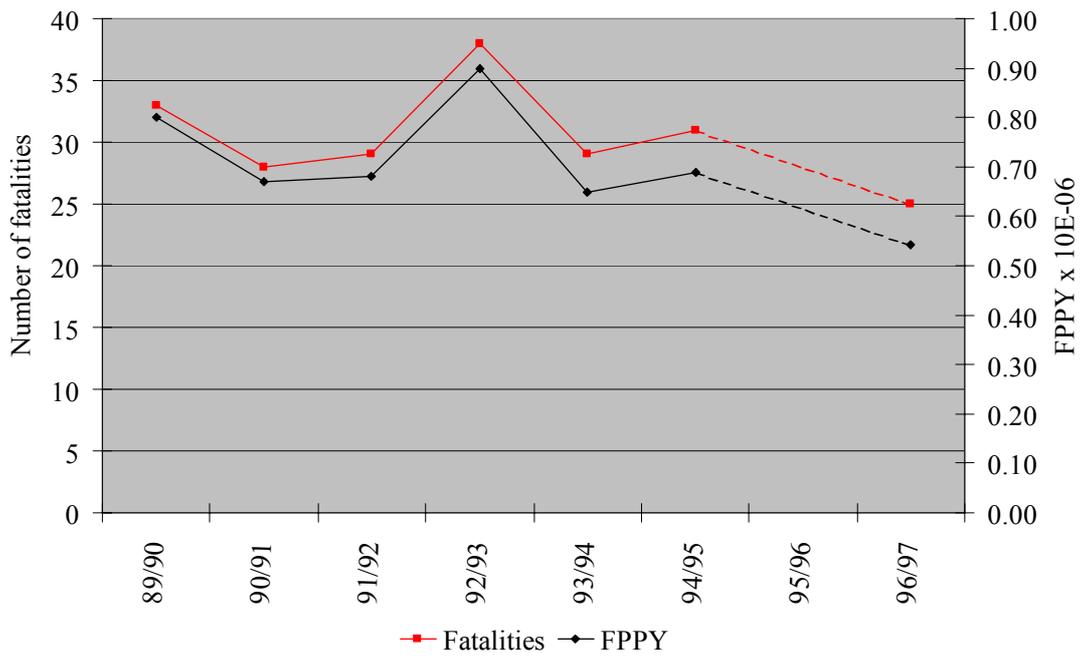
Figure 3 - Graph of fatality trends

Overall trends are given in Table 3 and plotted in Figures 3 and 4.

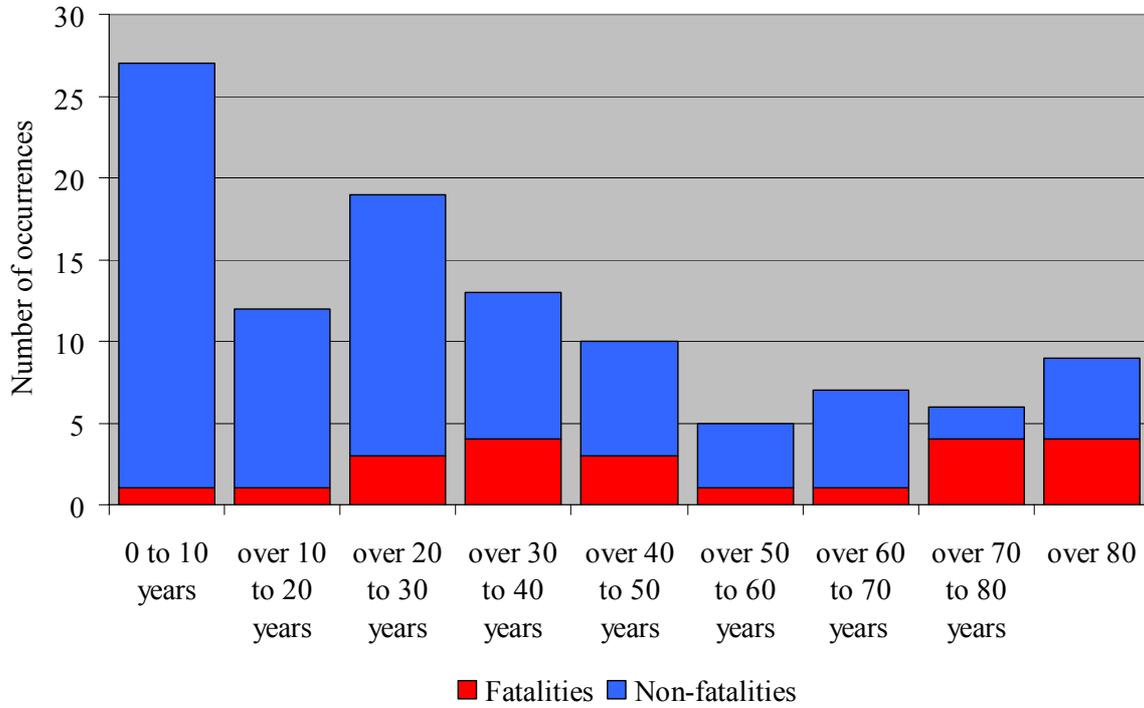
Figure 5 - Casualty age profile

The age and numbers of the combined totals of the fatal and all non-fatal casualties are given in Figure 5.

Note: this was for all incidents where the casualty age details had been completed.

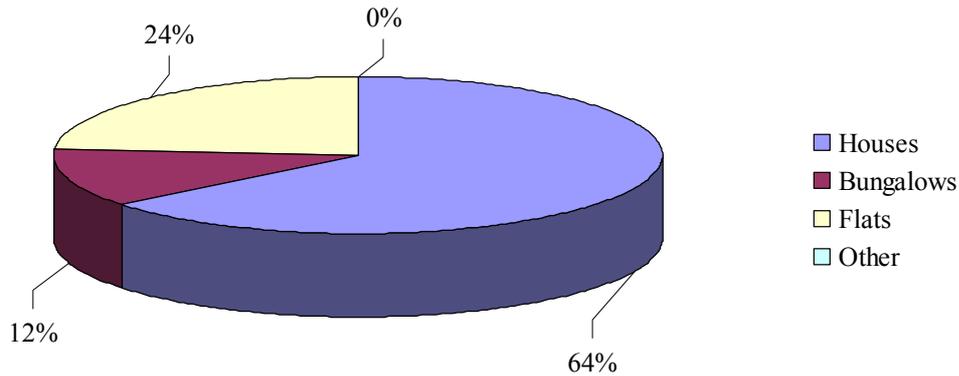
Figure 6 - Property types

Figure 6 indicates the proportion of houses (64%) that featured in incidents, compared to other property types. The second largest group was flats at 24%.

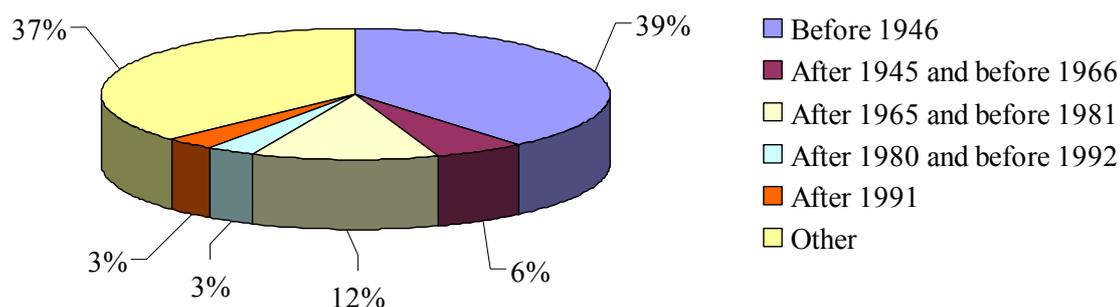
Figure 7 - Property construction period

The age bands of the properties in which incidents took place are shown on Figure 7.

The two largest sectors are properties built pre 1945 at 39% and unclassified at 37%. Where the age was specified (42 properties) the pre 1945 group is the majority at 62%. The next largest group was 19% for those built between 1966 and 1980. The Social Trends 27 publication, 1997 edition, from the Office for National Statistics (ONS) states that for Britain (for 1995/96) 41% of all dwellings were built before 1945, 23% were built in the period 1945 to 1964 and 35% were built during or after 1965.

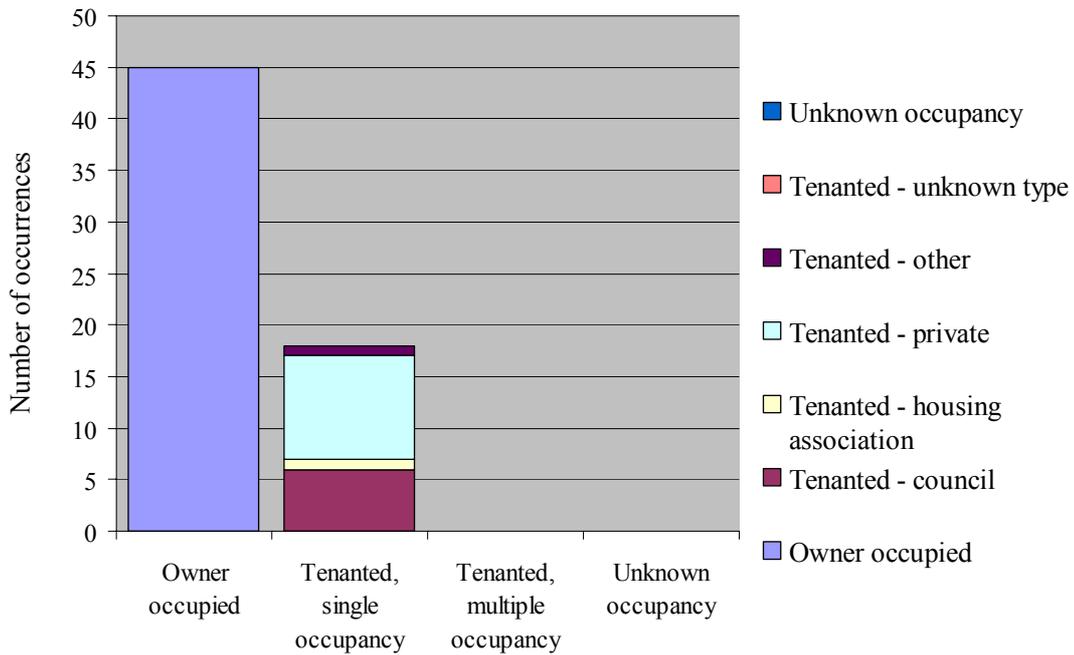
Figure 8 - Occupancy type

Figure 8 gives the occupancy types of the properties shown on the DIDR forms. The percentage owner occupied was 67% and 27% were tenanted. Empty fields or unrecognised values made up the remainder. Of the tenanted properties all 27% were single occupancy, with no multiple occupancy. The percentage of the tenanted sector that were council owned is 9%, privately owned was 15% and 1.5% were owned by a housing association, the remainder were classified as other.

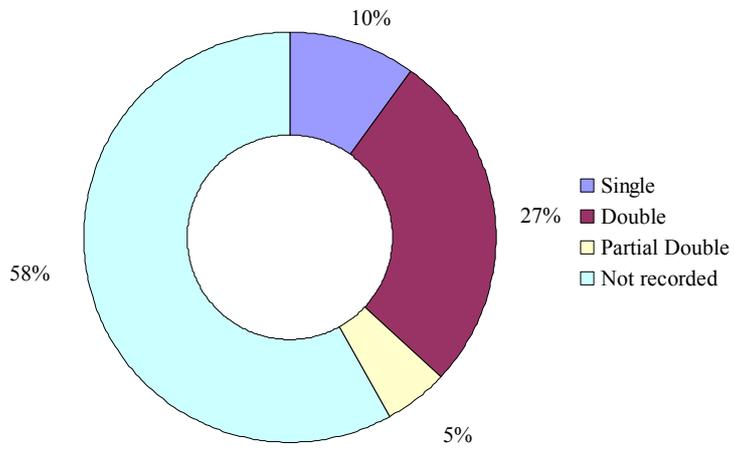
Figure 9 - Glazing details

Table 6 shows the analysis of the glazing and ground floor details for the incident sites. These are also described graphically in figures 9 and 10.

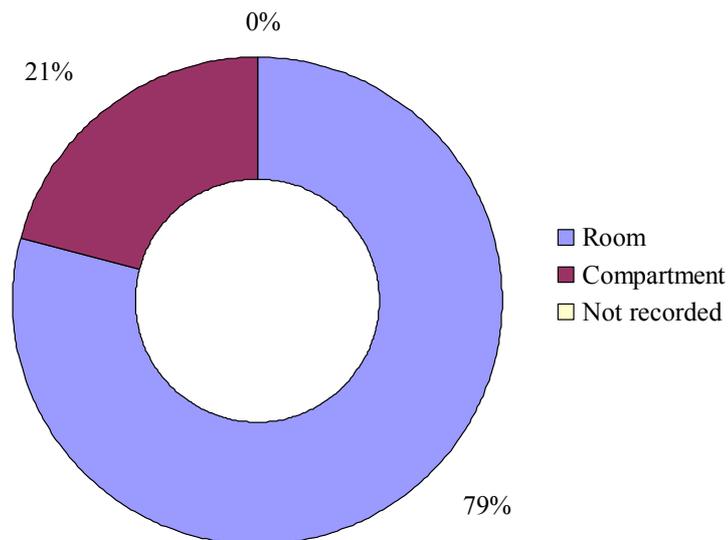
Figure 11 - Appliance location

Of the 67 incident sites the majority of incident appliances were located in rooms (79%). The remaining 21% were described as being located in compartments. This is shown on Figure 11.

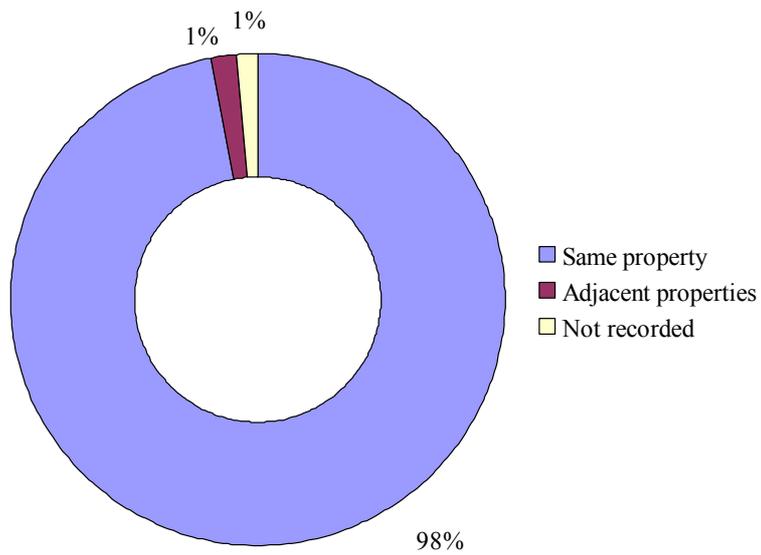
Figure 12 - Casualty/Appliance location

There was only 1 appliance located in a room below ground level. The majority of casualties were located in the same property as the incident appliance. This is shown on Figure 12. But in 1 instance the appliance was in an adjacent property, and in another incident the appliance was classified as “elsewhere”.

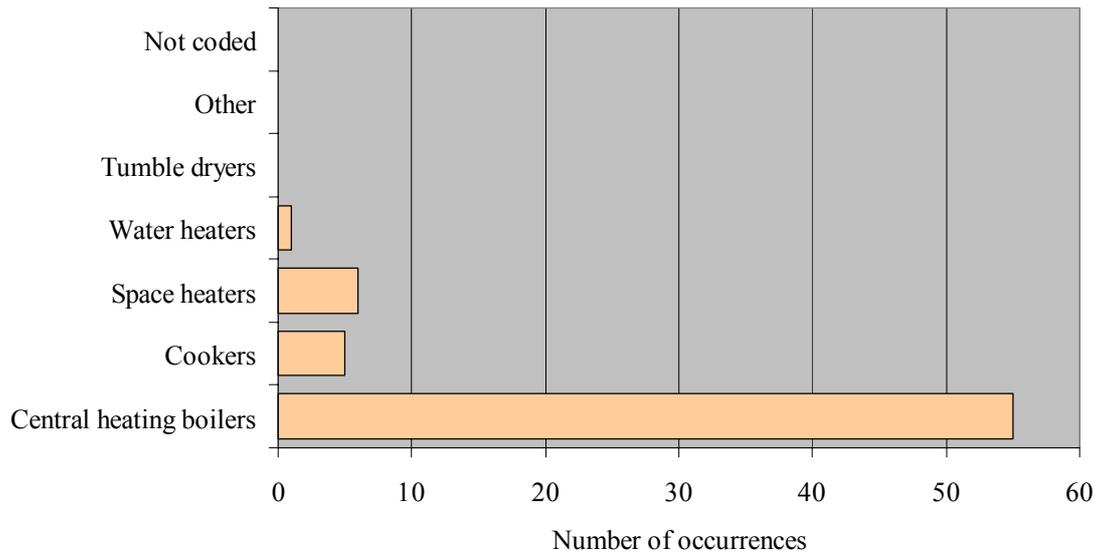
Figure 13 - Incidents by appliance type

Details of the CO poisoning incidents for 1996/97, by appliance type, are given in Table 8 and in Figure 13.

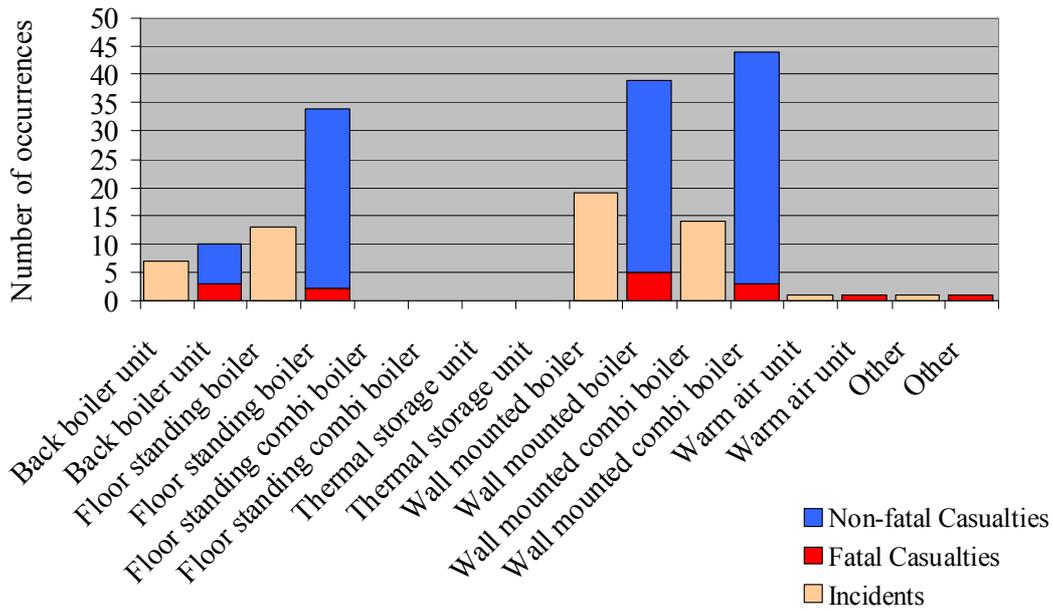
Figure 14 - Central heating boilers

The breakdown of the types of central heating units involved in incidents is given in Figure 14.

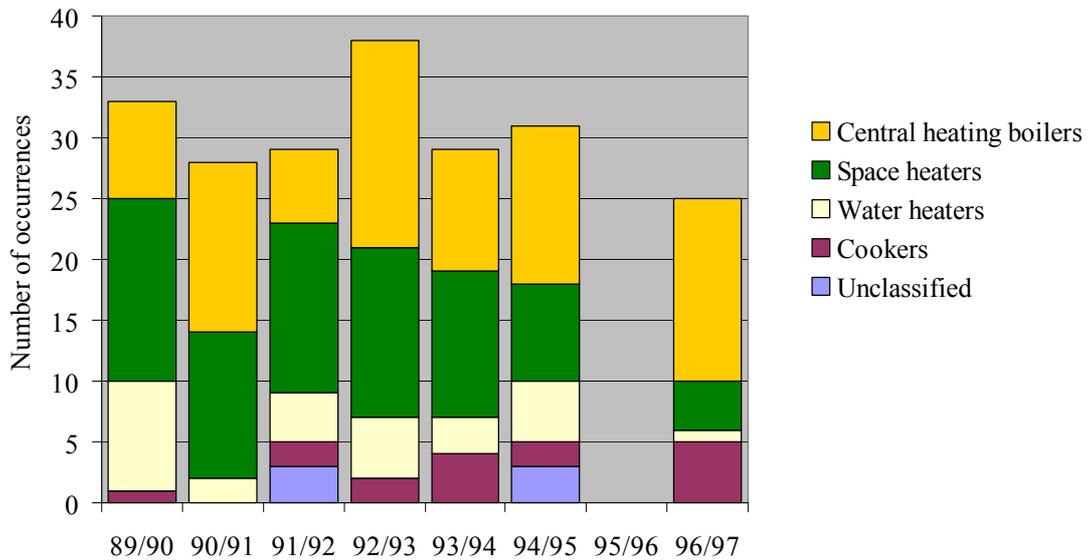
Figure 15 - Fatalities by appliance type

Figure 15 shows the fatality trends associated with appliance type since 1989/90. It should be noted that it is likely that there have been changes to the profile of gas appliances in use within Britain between 1989/90 and 1996/97. The FPPY risk values shown in Table 12 take account of the changes.

Trends regarding CO Poisoning incident fatalities by appliance type are given below in Table11 and are also shown in Figure 15 which is in section 2.5.1 of the report. This table has been completed as fully as possible using information that was available from the 96/97 DIDR forms and from historical records held by BG Technology (Reference 7.1.2). As future years are added to the table then the level of detail shown will improve.

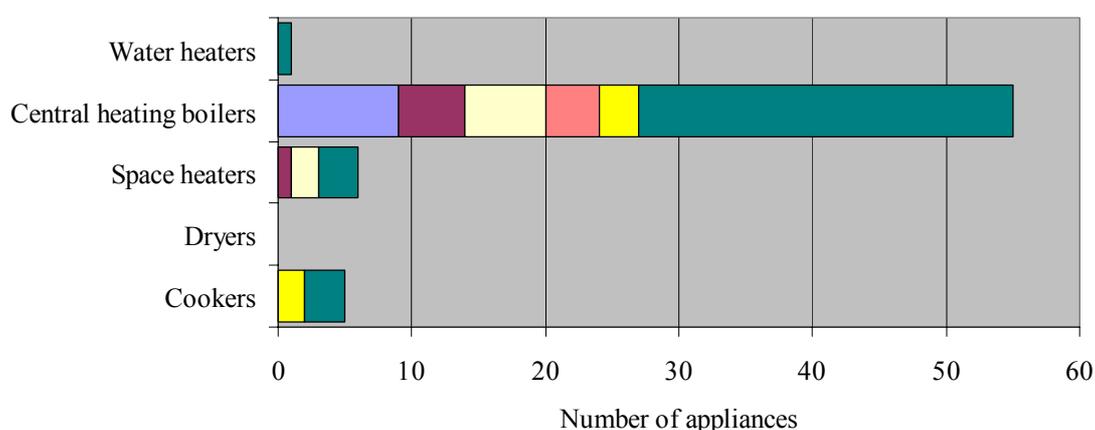
Figure 16 - Appliance age distribution

The age of the appliances involved in incidents during the reporting period has been given under the main appliance groups in Table 9. It is also described in Figure 16.

■ less than 6 years ■ 6 to 10 years ■ 11 to 15 years ■ 16 to 20 years ■ over 20 years ■ unknown

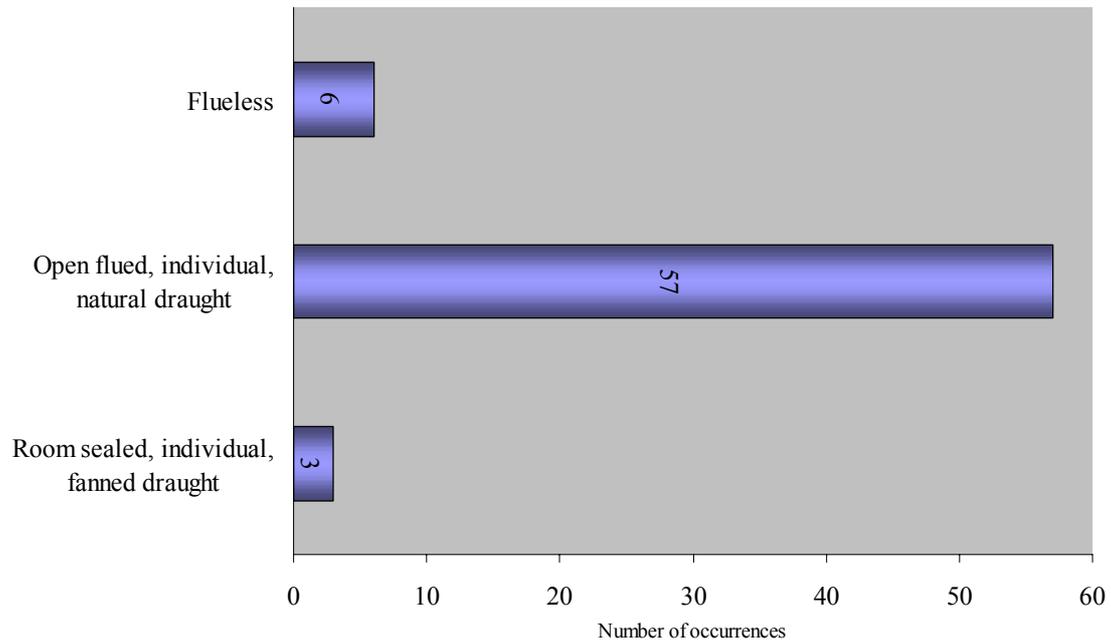
Figure 17 - Incidents by flue type

Of the total of 67 incidents (fatal and non-fatal), 57 (85%) involved individual open flued, natural draught appliances (52 boilers and 5 fires), with 6 (9%) involving flueless appliances (5 cookers, 1 water heater). Flueing details are given in Figure 17. Another 3 (4.5%) incidents involved individual room sealed, fan powered, central heating boilers. The flue type of the one remaining incident was unknown.

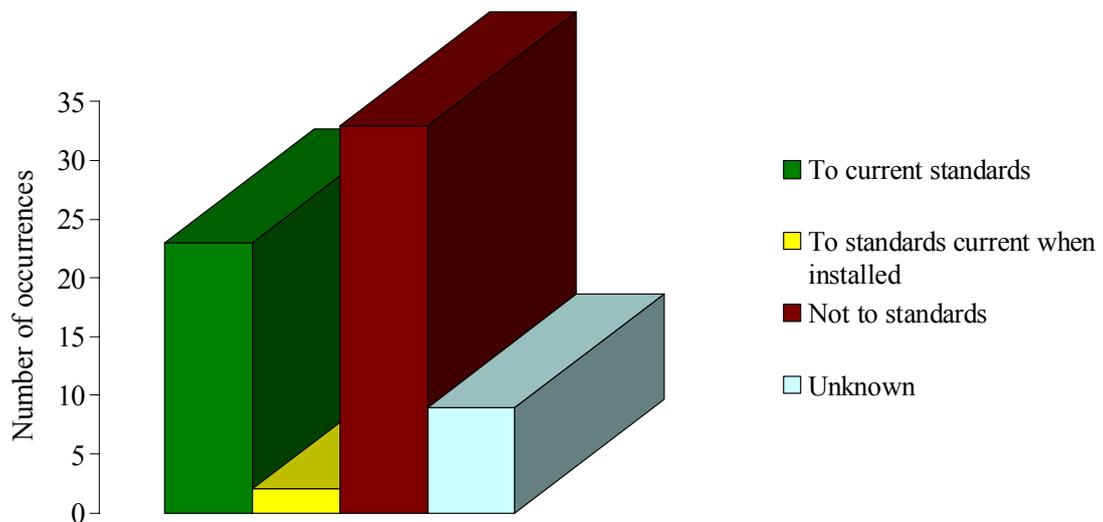
Figure 18 - Flues to standard

The analysis of flues to standard is given in Figure 18. There were 33 (49%) flues on incident appliances deemed to be not to required standards and 25 (37%) which were to current standards or the standard current when the appliance was installed. The remaining incidents were listed as unsure/don't know.

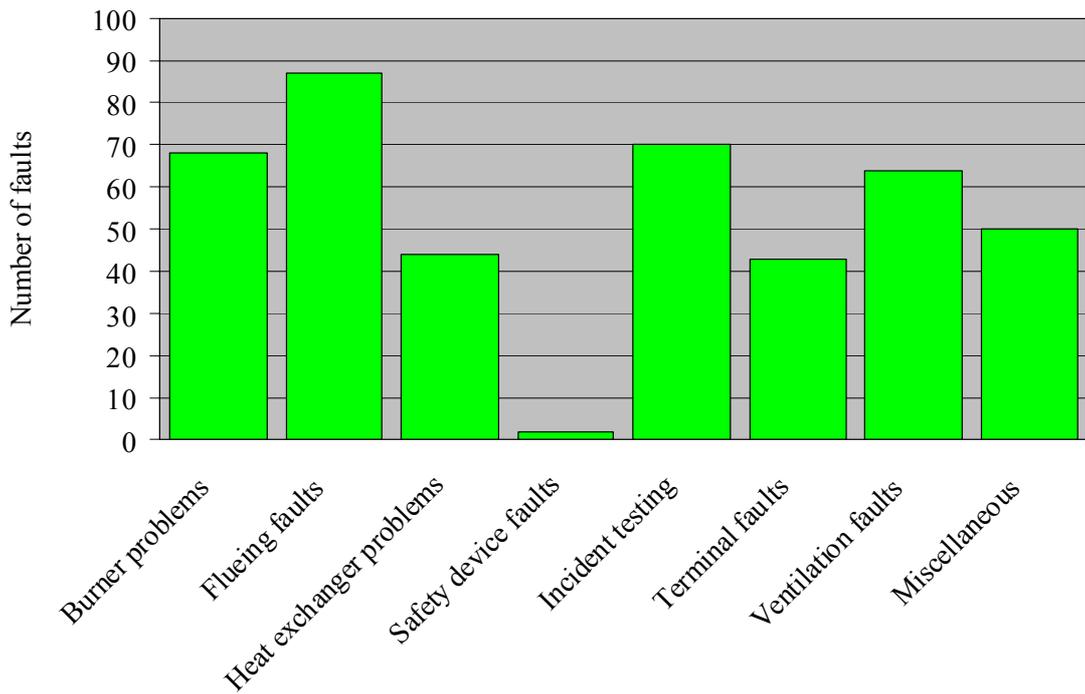
Figure 19 - Main fault groups

The following details in Table 13 are for all incident appliances. They give the total numbers of faults found upon incident appliances. In Appendix B a breakdown of the information from the DIDR is given by appliance type. The number of faults, by the main fault groups listed below, are given in Figure 19 and in Figure 20 each individual fault is shown, for comparison purposes.
