# **A review of carbon monoxide incident information for 1999/2000**

Produced from the full investigation of incidents  
which had resulted from the use of piped  
natural gas and LPG within Great Britain

Prepared by  
**Advantica Technology**  
for the Health and Safety Executive

**CONTRACT RESEARCH REPORT**  
**424/2002**

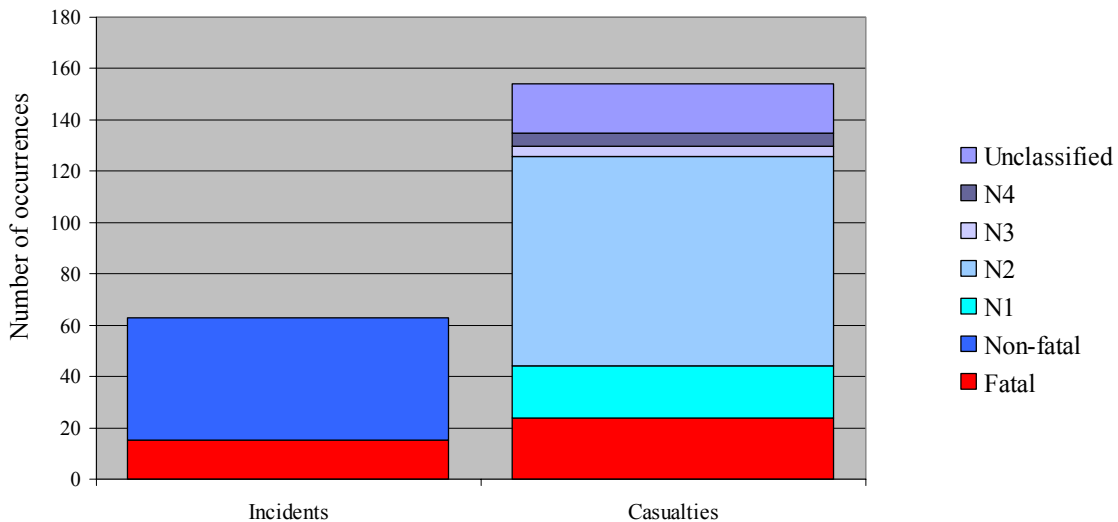
**Figure 2 - Incident analysis**

Figure 2 gives the number of reported domestic occurrences of CO incidents and CO casualties that took place during the year 1999/00. Further information on casualty groups are given in section 2.2 of this report.

Figure 2, in section 2.1, gives the number of occurrences of incidents and casualties that took place during the year.

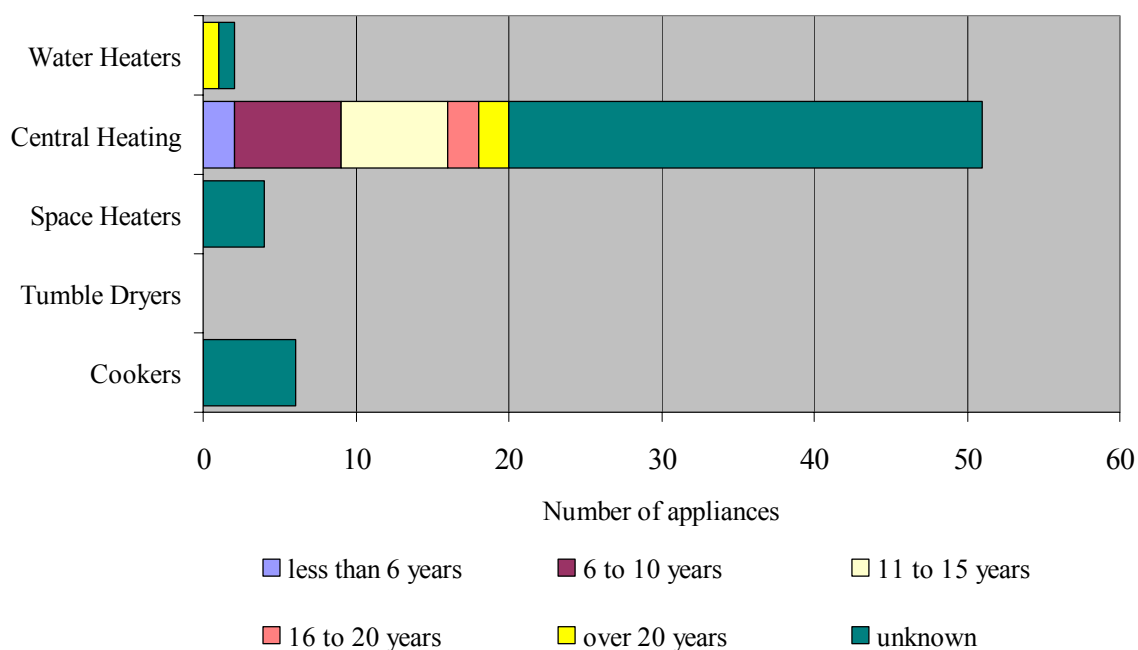
**Figure 16 - Appliance age distribution**

The age of the appliances involved in incidents during the reporting period has been given under the main appliance groups in Table 10. It is also described in Figure 16.

Trends regarding CO Poisoning incident fatalities by appliance type are given below in Table 12 and are also shown in Figure 16, which is in section 2.5.1 of the report. This table has been completed as fully as possible using information that was available from the 1999/00 DIDR forms and from historical records held by Advantica (Reference 7.1.2).

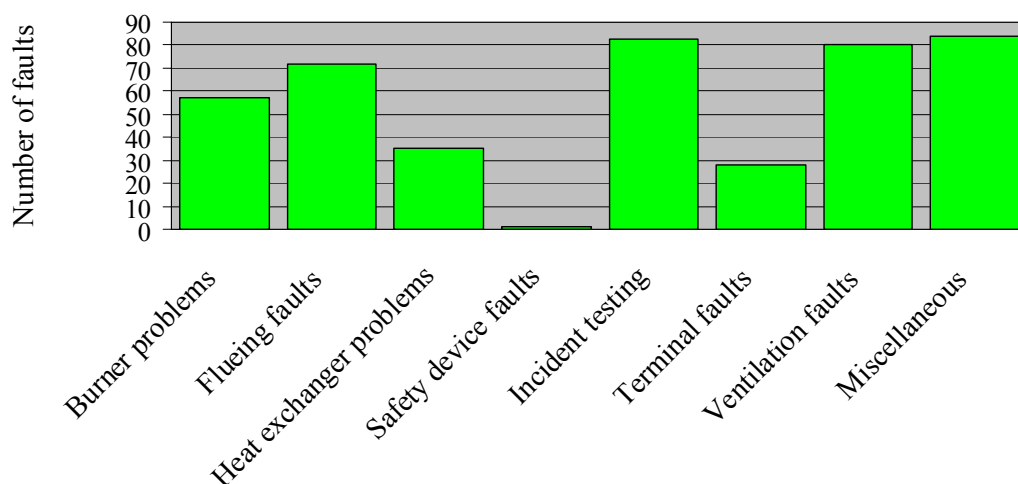
**Figure 21 - Main fault groups**

The following details in Table 16 are for all incident appliances. They give the total numbers of faults found upon incident appliances. In Appendix B a breakdown of the information from the DIDR is given by appliance type. The number of faults, by main fault groups, are listed below in Figure 21. This is followed by Figure 22 where for comparison purposes each individual fault has been shown,
