A review of carbon monoxide incident information for 2000/2001

Produced from the full investigation of incidents which had resulted from the use of piped natural gas and LPG within Great Britain

Prepared by
Advantica Technology
for the Health and Safety Executive 2002

RESEARCH REPORT 032

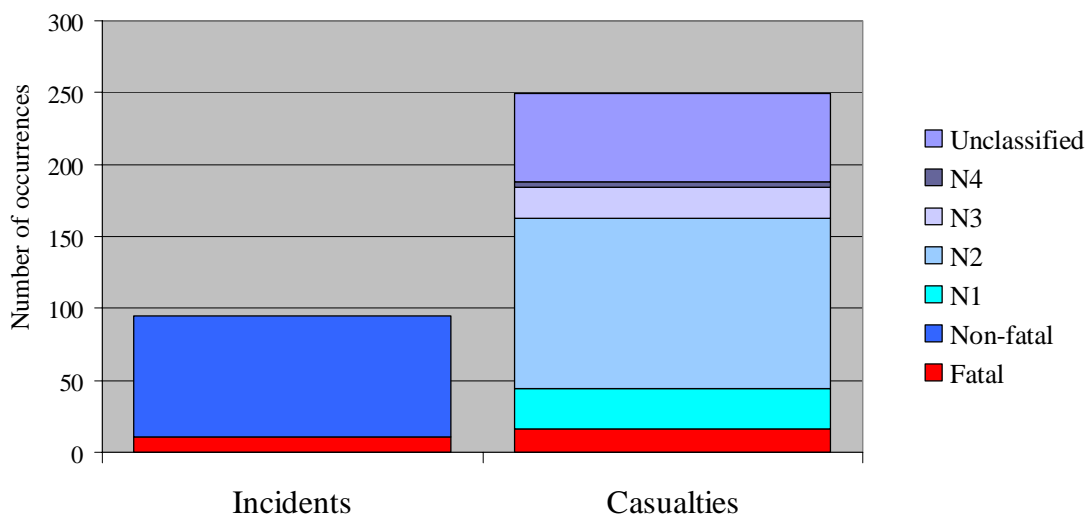
Figure 2 - Incident analysis

Figure 2 gives the number of reported domestic occurrences of CO incidents and CO casualties that took place during the year 2000/01. Further information on casualty groups are given in section 2.2 of this report.

Figure 2, in section 2.1, gives the number of occurrences of incidents and casualties that took place during the year. Using this information a corresponding risk data analysis has been carried out. The results from this are given in Table 2. The table also includes details of the number of fatalities and the number of incidents reported on the DIDR form.

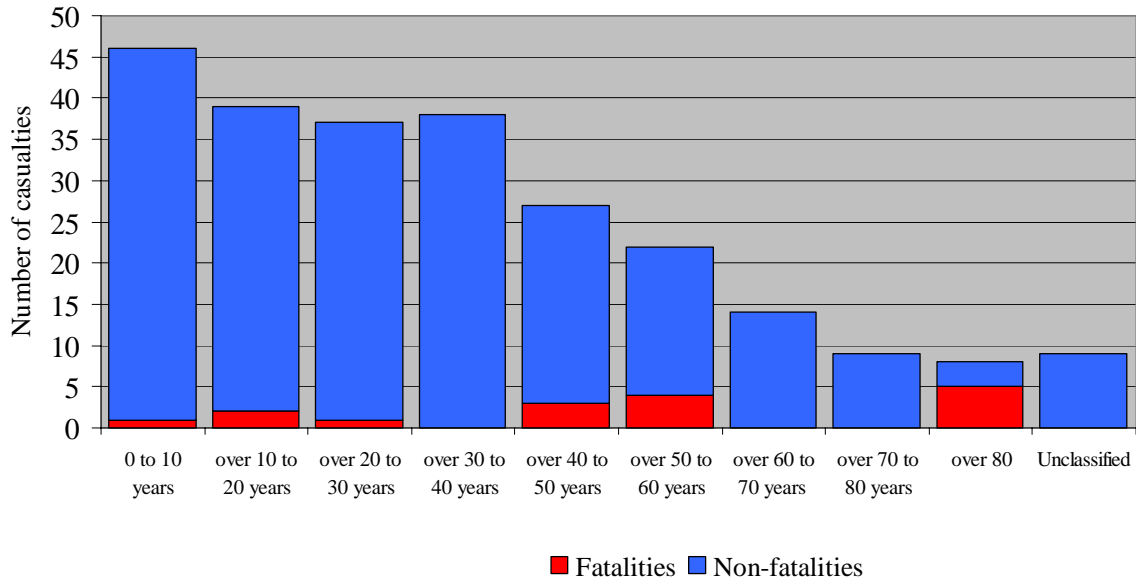
Figure 5 - Casualty age profile

The age and numbers of the combined totals of the fatal and all non-fatal casualties are given in Figure 5.

The casualty age profile, shown in figure 5, shows close similarity with the figures given in the previous three reports of this series. In relation to the age profile of the resident population of the United Kingdom for 1999, obtained from the office for National Statistics, the graph indicates that those above the 30 to 40 age band feature less in incidents than would be expected, and those below the 30 to 40 age band feature more than would be expected. The 0 to 10 age band exhibits the largest variation, by approximately 45% above what would be expected.

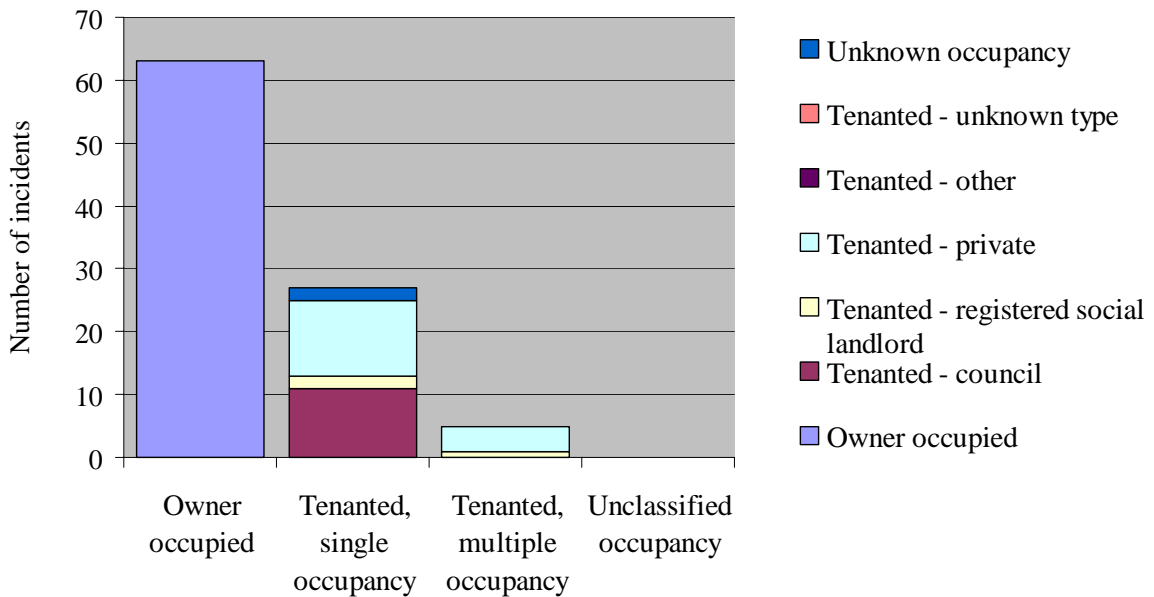
Figure 6 - Occupancy type

Figure 6 gives the occupancy types of the properties shown on the DIDR forms. The percentage owner occupied was 66% and 34% were tenanted. There were no empty fields or unrecognised values. Of the tenanted properties, 29% (27) were single occupancy and 5% (5) were multiple occupancy. The proportion of tenanted properties that were council owned was 11% (11), 3% (3) were owned by registered social landlords and 17% (16) were privately owned. In a further 2 incidents the landlord was unknown.

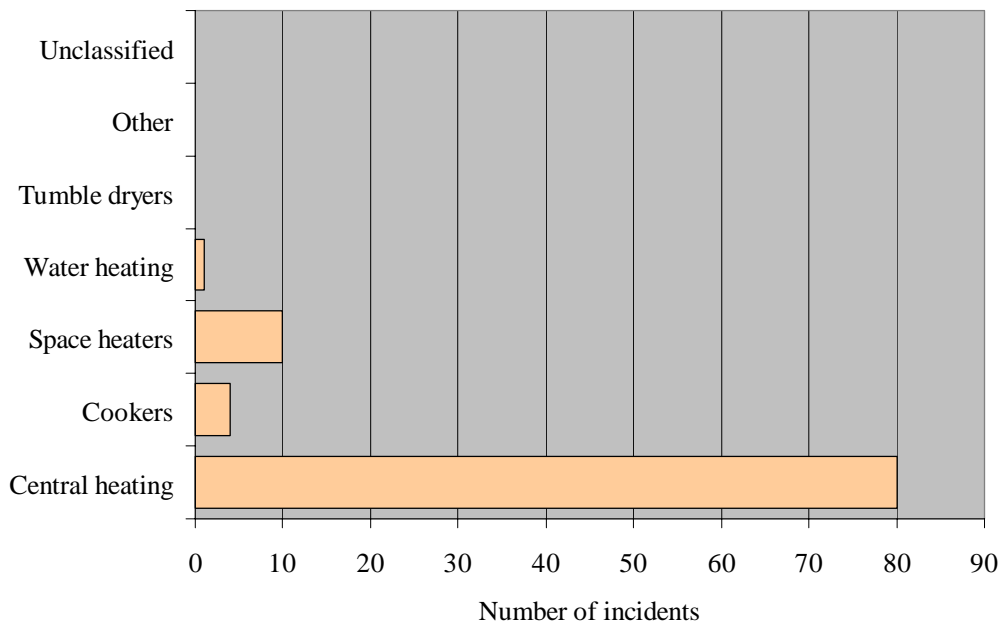
Figure 13 - Incidents by appliance type

Details of the CO poisoning incidents for 2000/01, by appliance type, are given in Table 9 and summarised in Figure 13.
