A review of carbon monoxide incident information, for 2004/05, produced from the full investigation of incidents which had resulted from the use of piped natural gas and LPG, within Great Britain

Prepared by **Advantica**
for the Health and Safety Executive 2007

A S Dhanjal BSc (Hons)
Advantica
Holywell Park
Ashby Road
Loughborough
Leicestershire
LE11 3GR

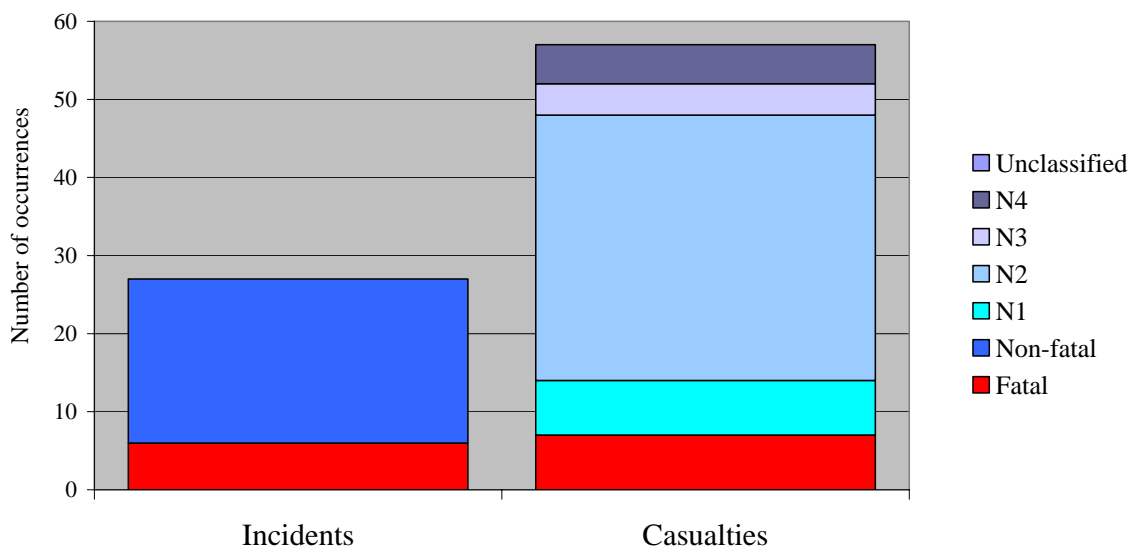
Figure 2 - Incident analysis

Figure 2 gives the number of reported domestic occurrences of CO incidents and CO casualties that were incurred during the year 2004/05. Further information on casualty groups is given within the notes to Table 1, in section 2.2 of this report.

Figure 2, in section 2.1, shows the number of occurrences of incidents and casualties that took place during the year. Using this information a corresponding risk data analysis has been carried out. The results from this are given in Table 2. The table also includes details of the number of fatalities and the number of incidents reported on the DIDR form that are embraced for compilation of the main section of this report.

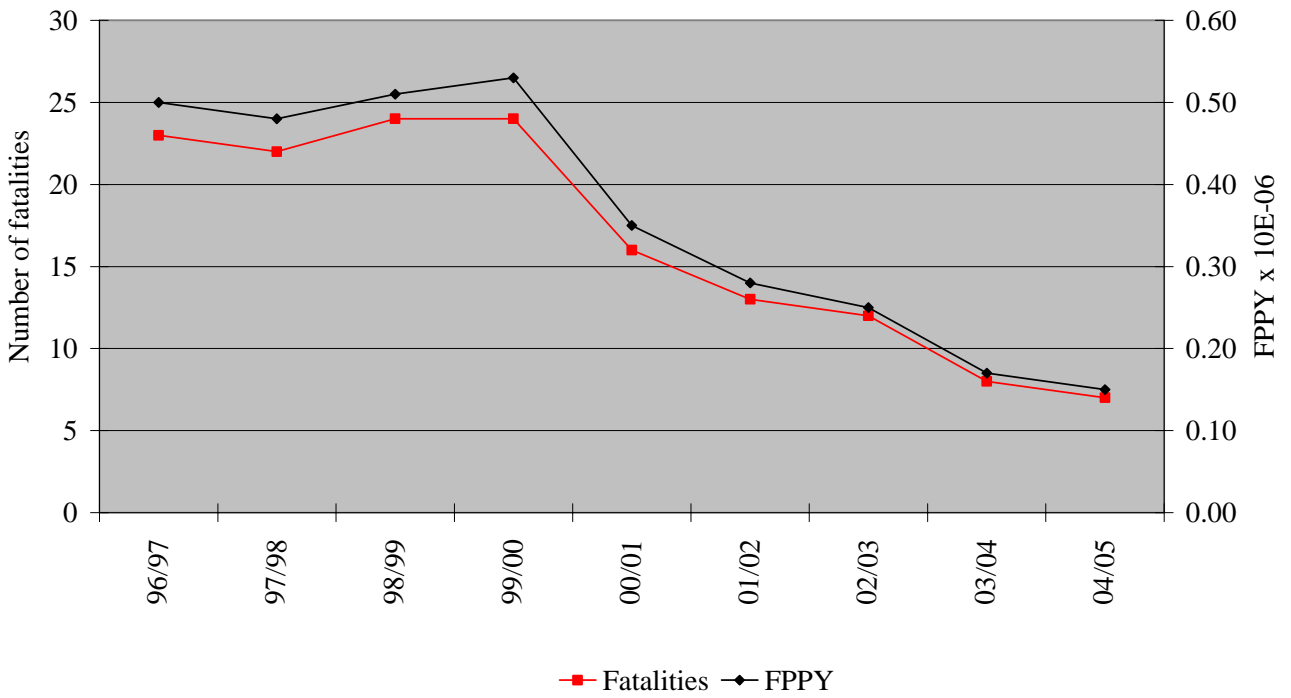
Figure 3 - Graph of fatality trends

Overall trends are given in Table 3 and plotted in Figures 3 and 4. Table 3 and Figure 4 have been updated to include the 3 non-fatal casualties arising in the 2003/04 incident outlined in Appendix E.

The total number of fatalities reported, at 7, was also the lowest since these records started. The previous minimum had been 8 in 2003/04. For the years 1996/97 to 2003/04 the number reported had been 16.0 ± 8.0 (8-32). The data shown in figure 3 indicates a noticeable reduction in the number of annual CO fatalities that are being reported on the DIDR forms over the last 5 reporting years. The over-all FPPY value of 0.15×10^{-6} is the lowest figure calculated since the commencement of this series of reports in 1996/97. This value of FPPY falls within, what would normally be considered as, the “broadly accepted region” of HSE’s criteria for the tolerability of risk. However, societal concerns over gas safety override averaged risk considerations.

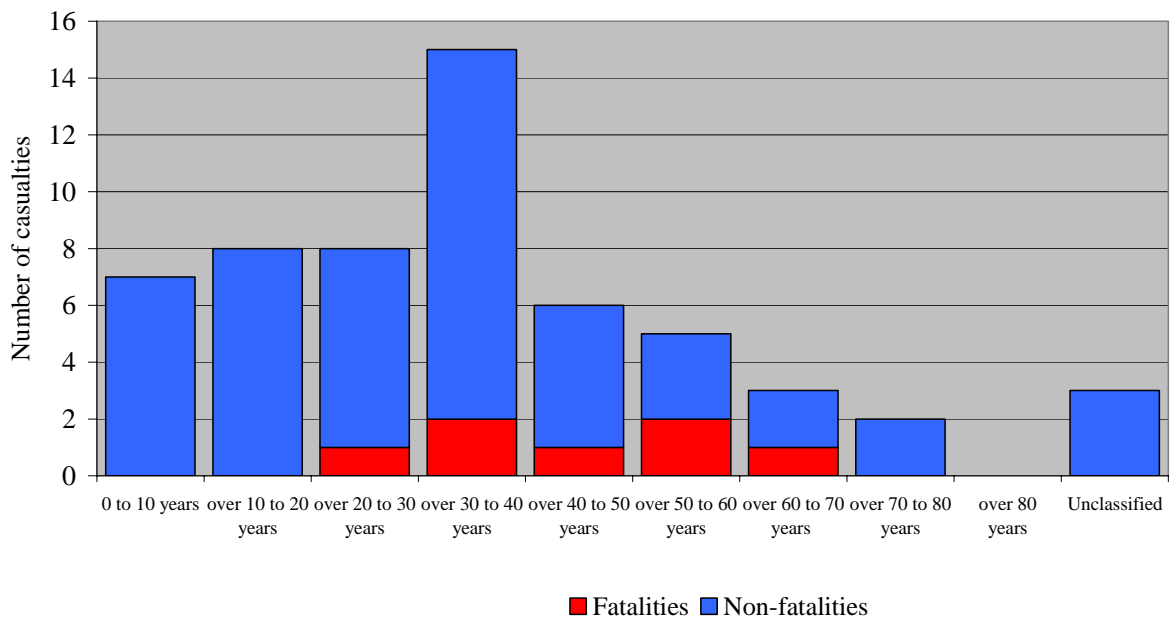
Figure 5 - Casualty age profile

The age group, along with the numbers of fatal and non-fatal casualties, are given in Figure 5. The combined totals for all casualty groups are compared to the mid-2004 population estimates for GB, projected by the Office for National Statistics, in Table 4.

The casualty age profile, shown in Figure 5, may be examined by comparing fatal and non-fatal numbers in isolation with earlier years. Whilst the non-fatal age distribution shows similarity with the figures given in the previous 8 reports of this series, the low number of fatal casualties reported gives a scatter and making a comparison is not worthwhile. There were no fatalities in the 0-20 years age grouping (there were 3 in this age band in the previous year), and 4 of the 7 deaths were in the 20-50 year band.

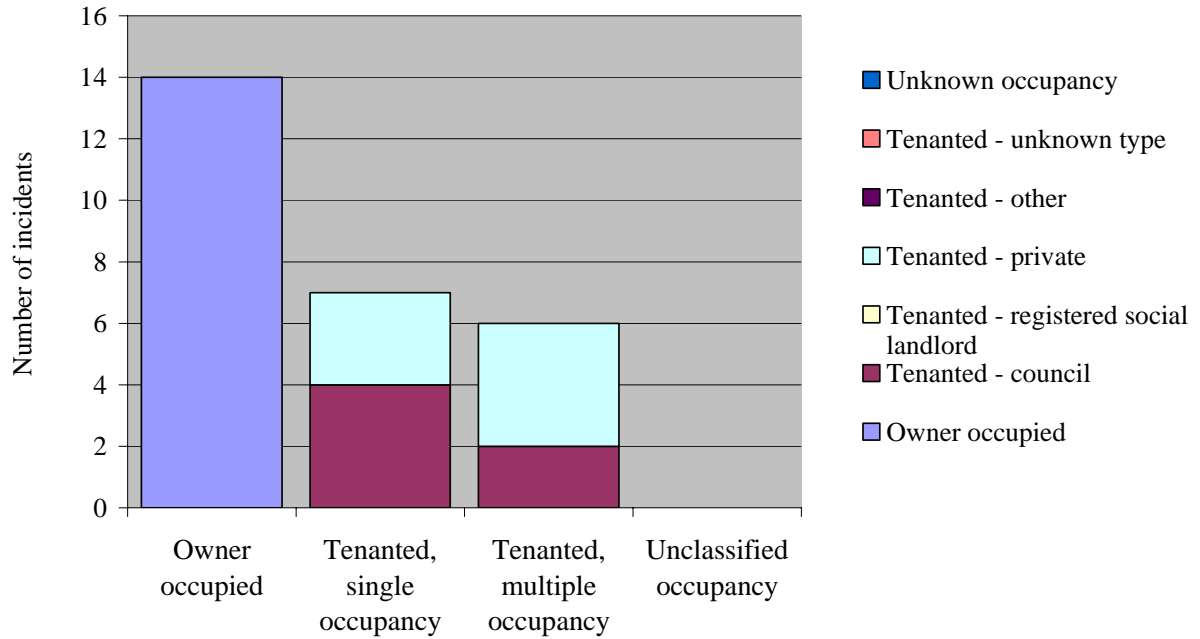
Figure 6 - Occupancy type

Table 5 and Figure 6 indicate the tenure of the properties derived from the DIDR forms. This shows a slightly higher representation for owner occupied properties than tenanted properties. There were no empty fields or unrecognised values. A break down of tenanted properties exhibits 26% (7) were single occupancy and 22% (6) were multiple occupancy. Dwelling stock tenure data for March 2005 for Great Britain, published by the Office of the Deputy Prime Minister, gives a breakdown of the occupancy groups. These statistics are reproduced in Table 5 for comparison.

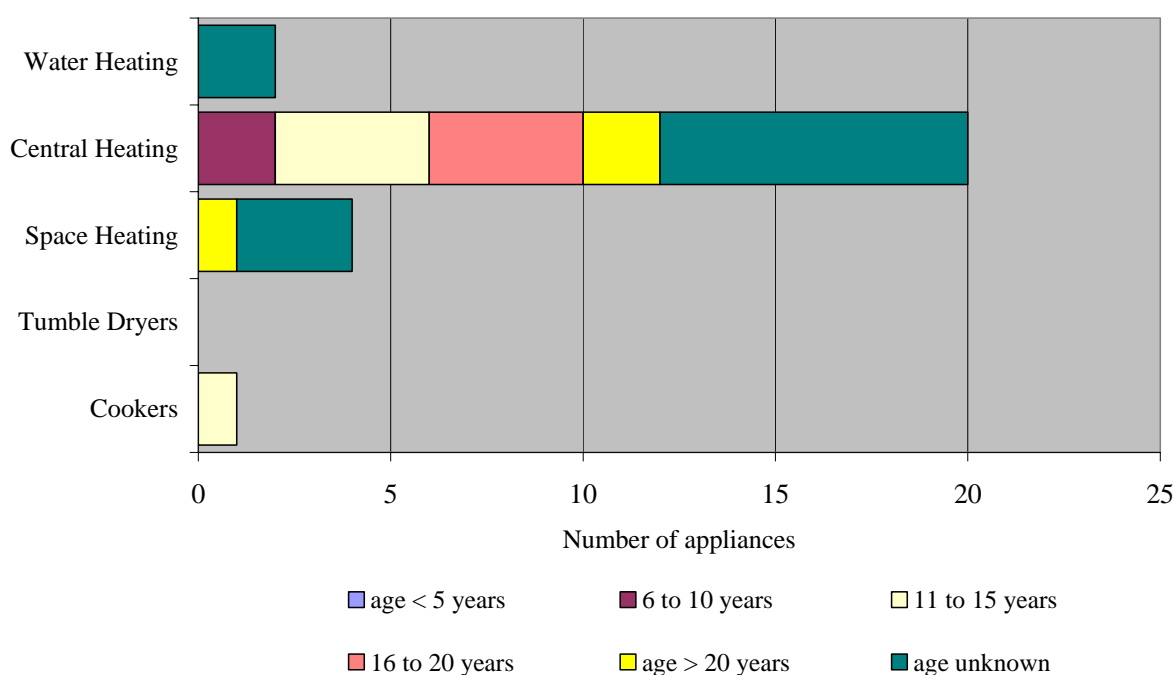
Figure 16 - Appliance age distribution

The age of the appliances involved in incidents during the reporting period is given under the main appliance groups in Table 13. It is also shown in Figure 16. Appendix E contains data commissioned for this report on population and age profile of piped natural gas appliances used within Great Britain.

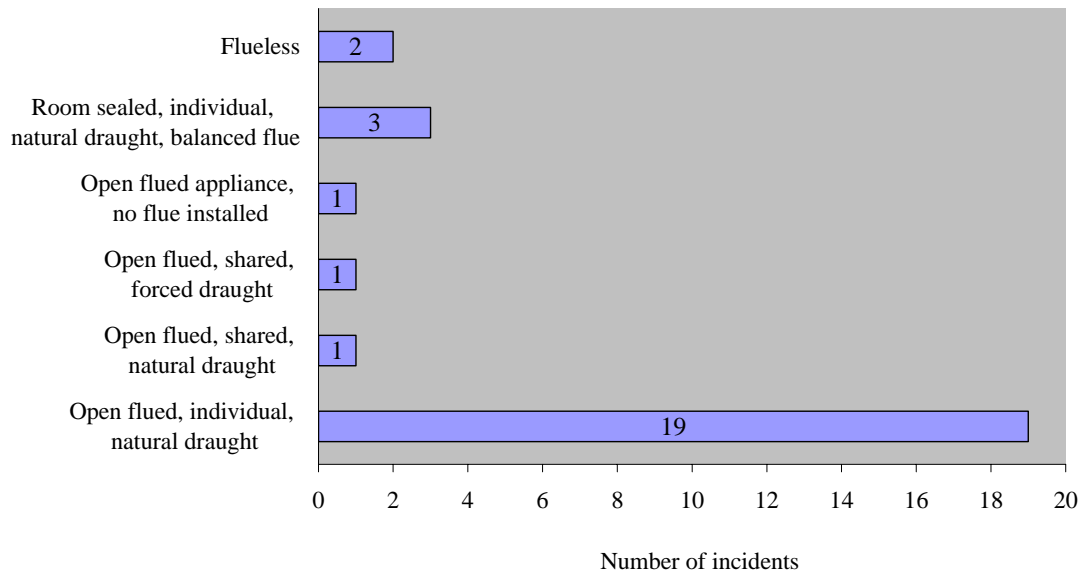
Figure 17 - Incidents by flue type

The majority of appliances, 20 (80%) were fitted with open, individual, natural draught flues (includes the incident with the open flue gas fire without any flue provision). There were also 3 (12%) appliances with room sealed, individual, natural draught, balanced flues, and 2 were flueless.. Flue type details are given in Figure 17.
